NBS CIRCULAR 550

**Mechanical Failures
of Metals in Service**

For many years the National Bureau of Standards has made examinations of metal parts that have failed in service for evidence bearing on the causes of failure. Thirty-five such cases, representing the most frequently observed types of failures are described, and the factors of design, fabrication, or use contributing to these failures are presented. The characteristics by which the various types of fractures can be recognized are discussed, and recommended precautions that should be observed to reduce mechanical failures of metals in service are included.

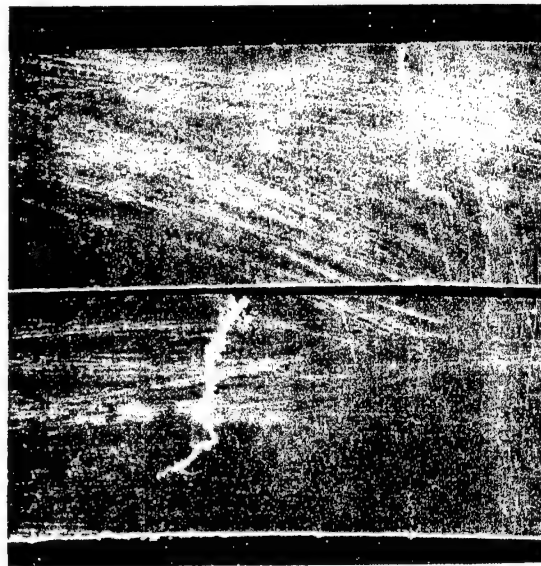
FIGURE 32.3. Cross sections of the tube wall, showing the depth of penetration of the cracks. $\times 7$.

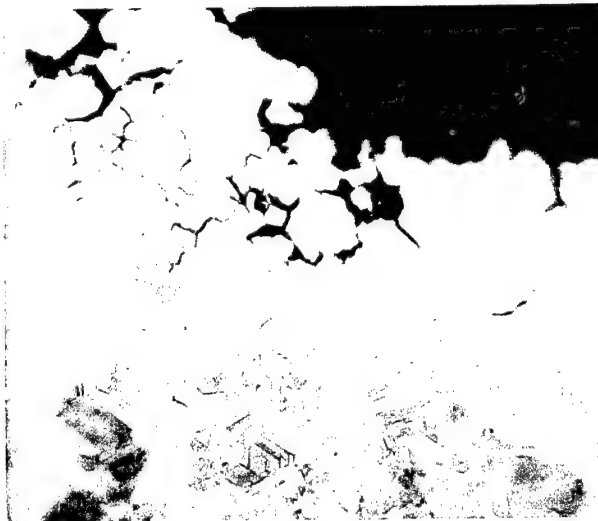
FIGURE 34.2. *Longitudinal section near the fracture, showing the intercrystalline cracks typical of stress-corrosion failures.*

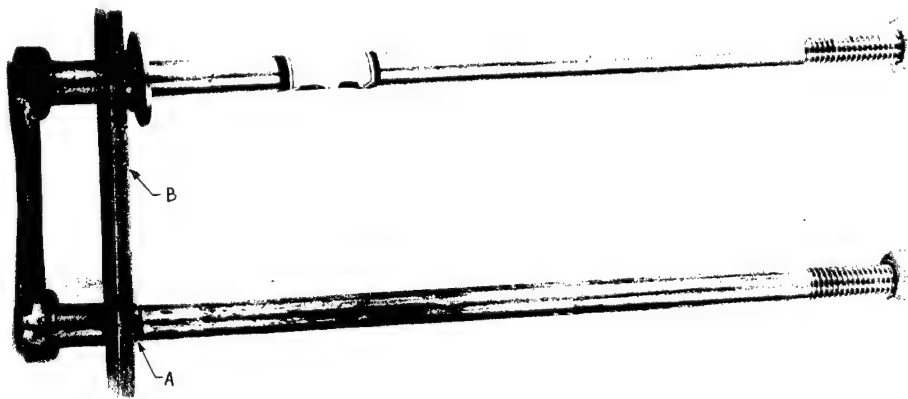
FIGURE 34.1. *Window washer's anchor with one bolt broken at arrow A.*

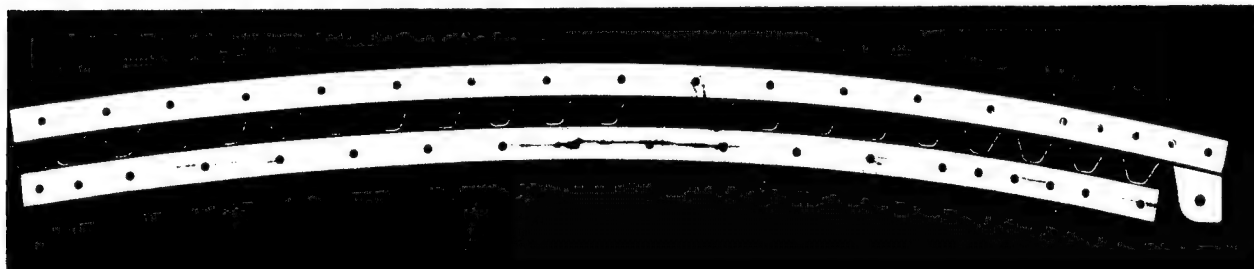
FIGURE 35.1. Cracks in the lower angle as revealed by a dye penetrant inspection method. The longitudinal cracks were caused by a tensile stress in the transverse direction. $\times \frac{1}{8}$.

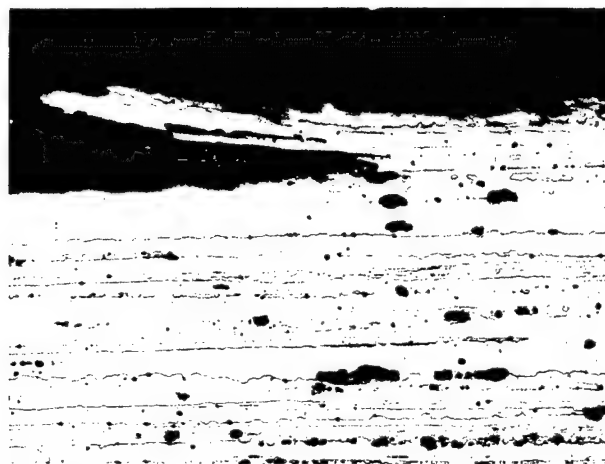
FIGURE 35.3. Longitudinal section perpendicular to the fracture shown in figure 35.2.
